Village of East Dundee
PRESIDENT AND BOARD OF TRUSTEES
Committee of the Whole
Monday, November 14, 2016
06:30 PM

Subject: Residential Façade Program Policy

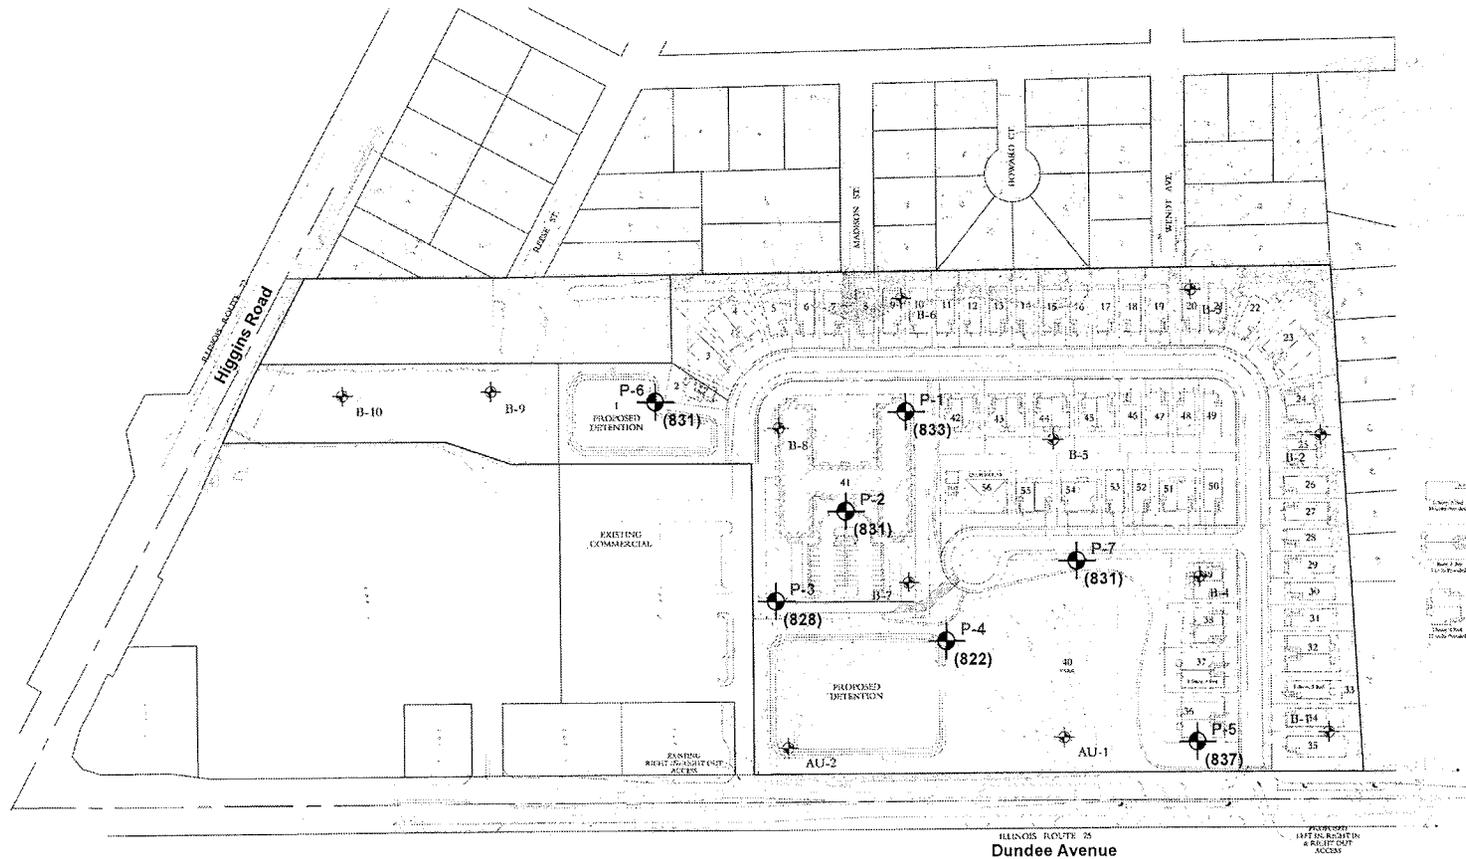
Note: borings designated B-1 to B-10 and AU-1 to AU-2 were from a previous subsurface exploration by another firm.

The original plan for both of the detention facilities was to be a dry bottom pond with French drains to promote infiltration into the existing sand/gravel layer. Soil Boring No. 4 from the original boring log shows that the gravelly sand layer runs approximately from 814.5 elevation down to 802. The gravelly sand layer may continue but the boring log stops at this elevation. The bottom of both detention ponds were set at an elevation of 816 with trench French drains proposed down to “a depth necessary to reach in situ gravel/sand layer”. The secondary outlet for the ponds is thru a storm sewer that has a release elevation of 820.21. Since the gravity release is approximately 4’ higher than the bottom of the pond, infiltration is required to keep the ponds dry.

The main pond in front of the senior apartments building has been holding water and is not operating as planned. The as-builts show that the pond bottom elevation has been altered from 816 down to 805. The original boring log shows that groundwater was not encountered down to 802. Soil borings were also taken near the pond in the fall of 2014 to see if there existed gravelly soils to make a hydraulic connection to promote infiltration. The two (2) logs show that no groundwater was encountered and the auger could not go deeper than 18 feet due to cobbles. Cobbles would be the ideal strata for introducing a connection for infiltration. There has been mentioned that the infiltration is taking place but the surface water elevation is at the water table elevation and therefore will always exist. The gravel pit to the east gives us a very good visual representation of the elevation of the water table in the area. We have taken survey shots on both water surface elevations and the Palumbo property lake is approximately 10 feet lower than the surface water elevation in the pond. We believe that during construction the earth moving operations and poor erosion control within the pond has contributed to plugging up the necessary voids to maintain the required infiltration.
