A Red Light Running (RLR) Photo Enforcement System was installed at the intersection of IL Route 31/8th Street and Boncosky Road on September 1, 2008 after finding limited success with other attempted measures to promote safer driving and improve compliance with traffic laws. As a condition of use, both Illinois law and the Illinois Department of Transportation require periodic statistical analyses / evaluations be conducted.

IL Rte. 31/8th Street at Boncosky Road West Dundee, IL

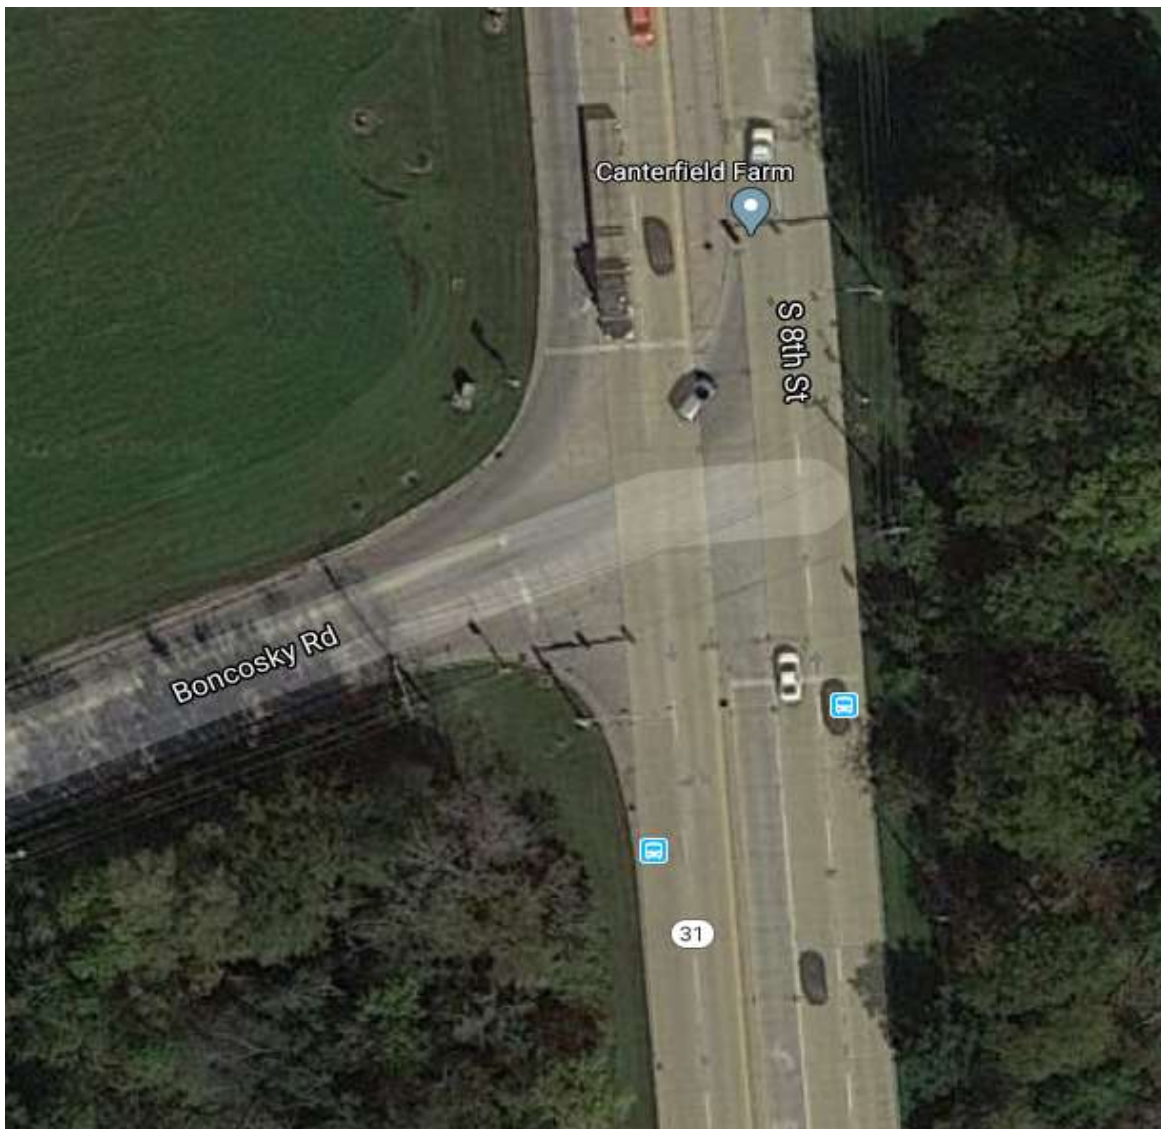
- RLR Photo Enforcement System monitors violations occurring on the southbound approach of the intersection
- RLR Photo Enforcement System installed: September 1, 2008
- Traffic signal timing strictly adheres to the guidelines for timing of clearances established by the Illinois Department of Transportation (IDOT), in accordance with the MUTCD standards. Neither the Vendor nor the Village has access to or influence over the establishment of signal timings. Both entities understand that tampering with these timings would be a safety violation with significant consequences.

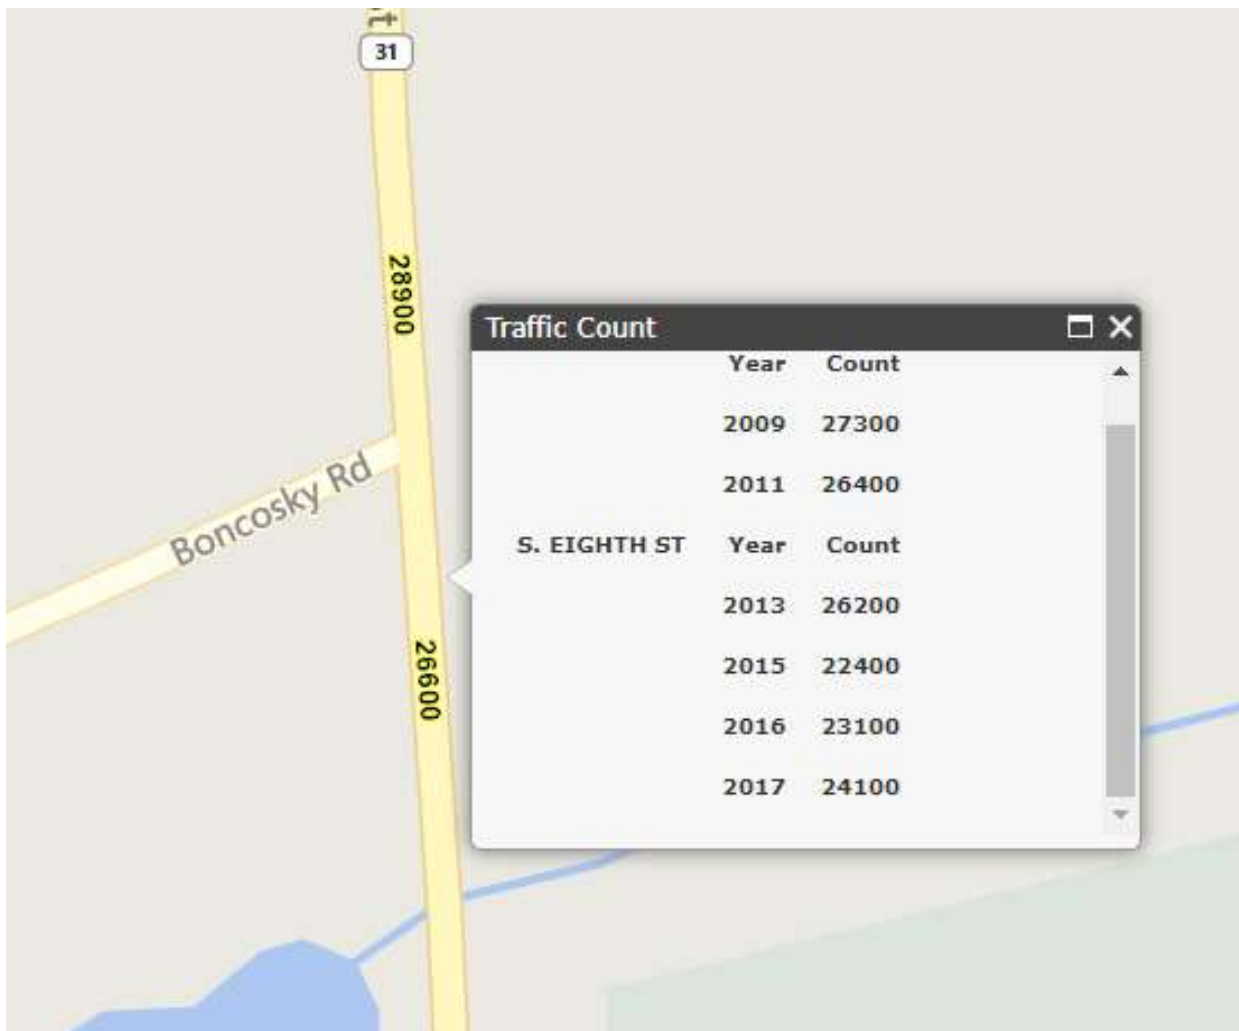
IL Rte. 31/8th Street at Boncosky Road (Northbound)

- 27,300 (2009)
- 26,400 (2011)
- 26,200 (2013)
- 22,400 (2015)
- 23,100 (2016)
- 24,100 (2017)
- 26,600 (2019)

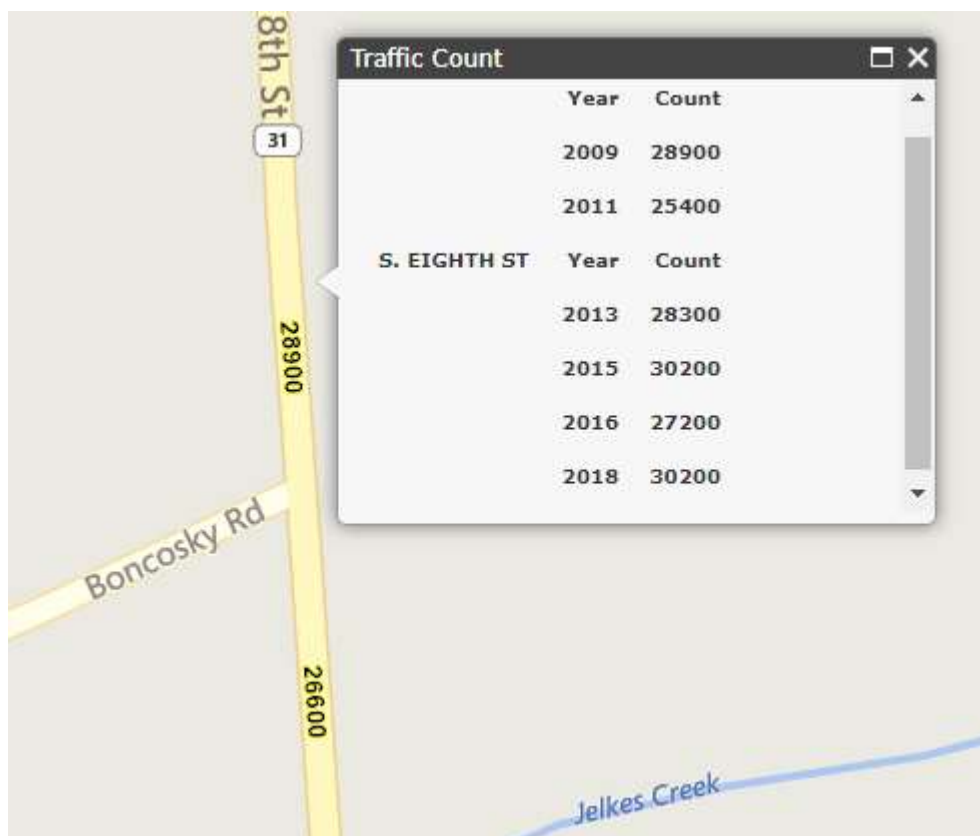
IL Rte. 31/8th Street at Boncosky Road (Southbound)

- 28,900 (2009)
- 25,400 (2011)
- 28,300 (2013)
- 30,200 (2015)
- 27,200 (2016)
- 30,200 (2018)
- 28,900 (2019)

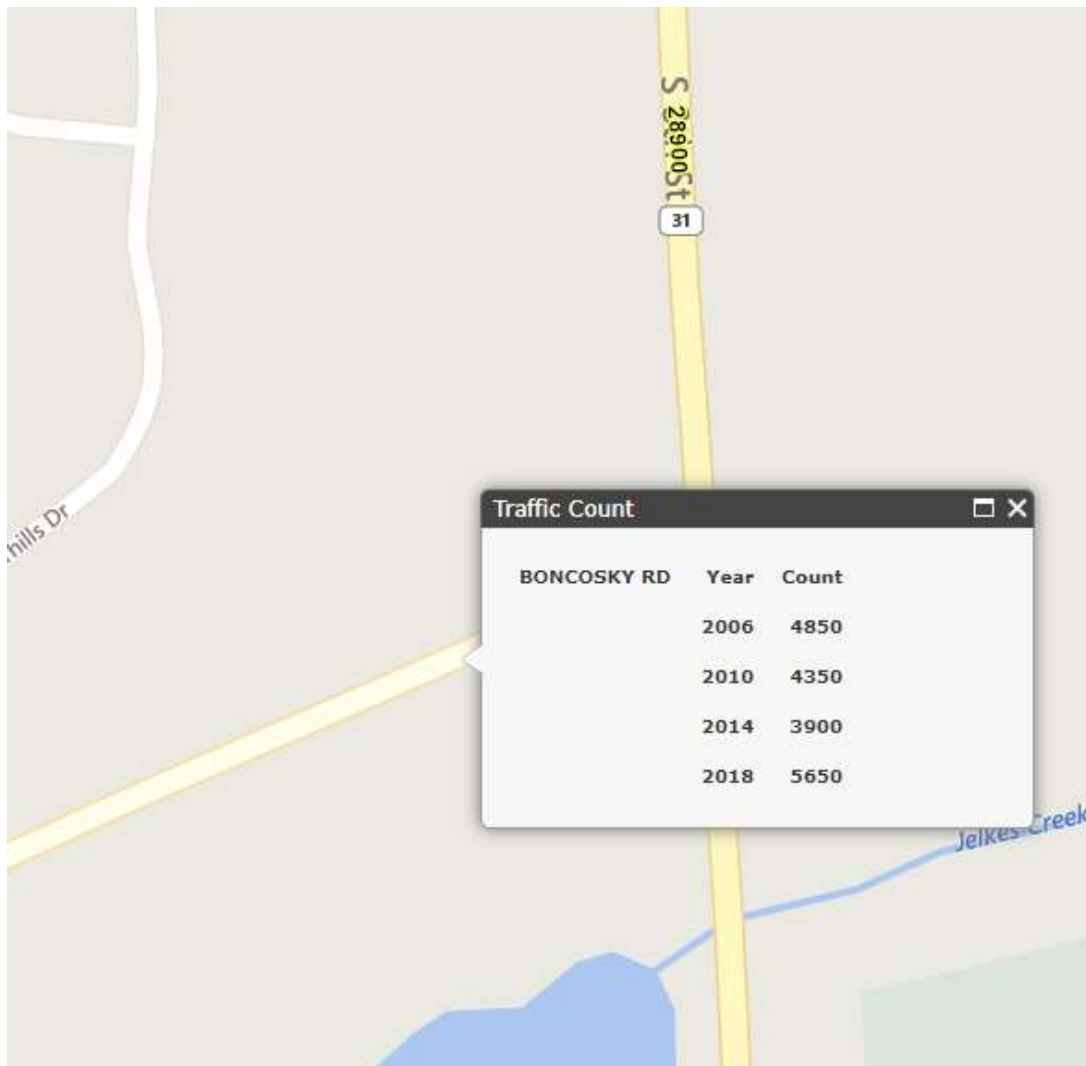
IL Rte. 31/8th Street at Boncosky Road (Eastbound)

- 4,850 (2006)
- 4,350 (2010)
- 3,900 (2014)
- 5,650 (2018)
