A Red Light Running (RLR) Photo Enforcement System was installed at the intersection of IL Route 31 and IL 72 on December 1, 2008 after finding limited success with other attempted measures to promote safer driving and improve compliance with traffic laws. As a condition of use, both Illinois law and the Illinois Department of Transportation require periodic statistical analyses / evaluations be conducted.

IL 31 at IL 72
West Dundee, IL

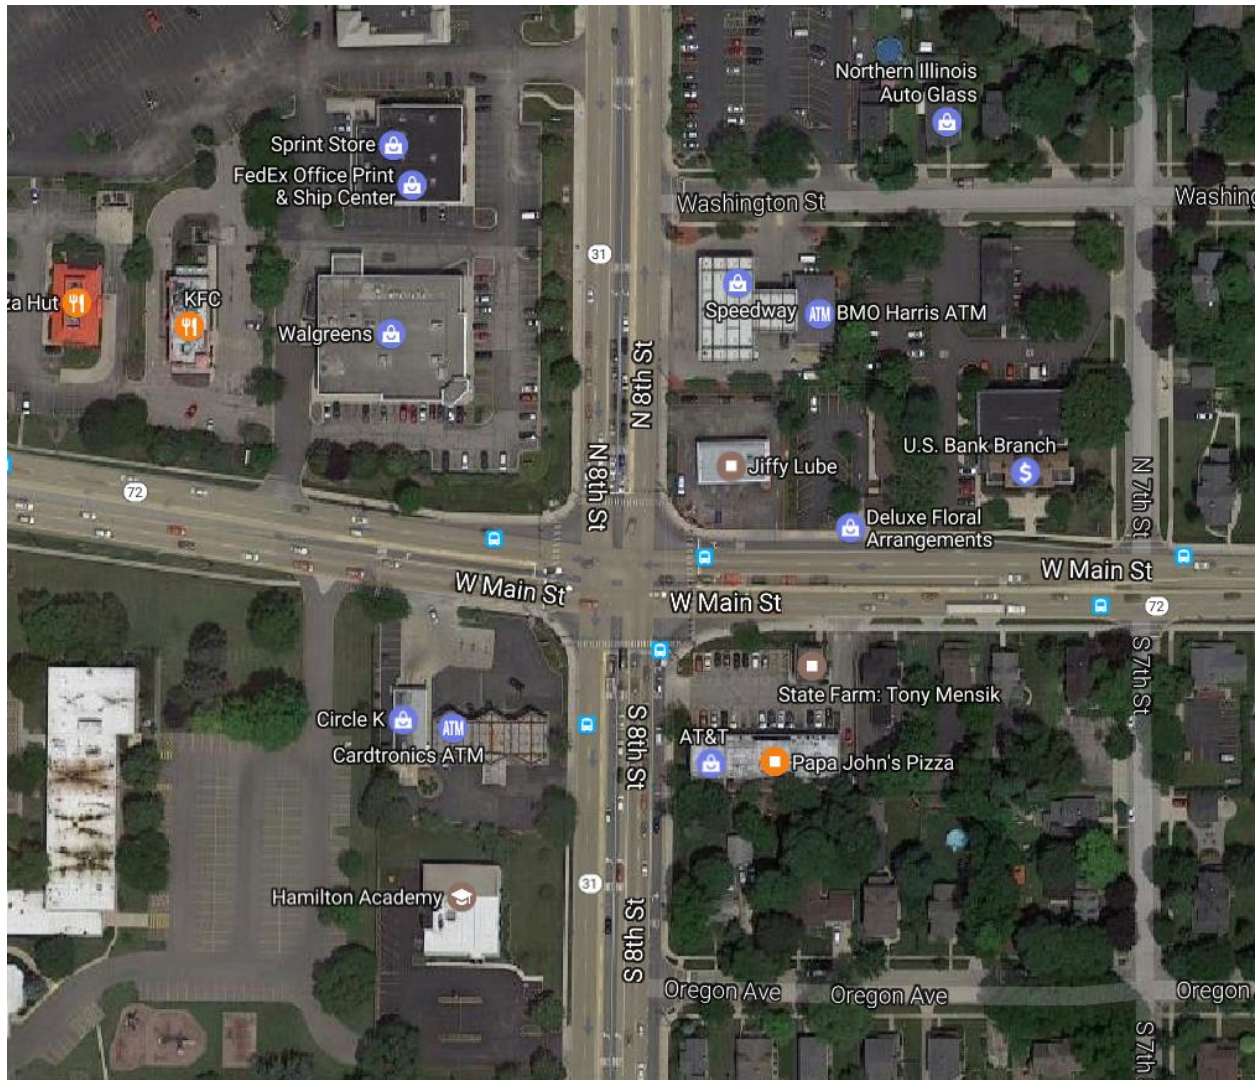
IL 31 at IL 72- Northbound Approach

- RLR Photo Enforcement System monitors violations occurring on the northbound approach of the intersection
- RLR Photo Enforcement System installed: December 1, 2008
- RLR Photo Enforcement System removed: April, 2013
- RLR Photo Enforcement System re-installed post-construction: August 12, 2015
- Traffic signal timing strictly adheres to the guidelines for timing of clearances established by the Illinois Department of Transportation (IDOT), in accordance with the MUTCD standards. Neither the Vendor nor the Village has access to or influence over the establishment of signal timings. Both entities understand that tampering with these timings would be a safety violation with significant consequences.

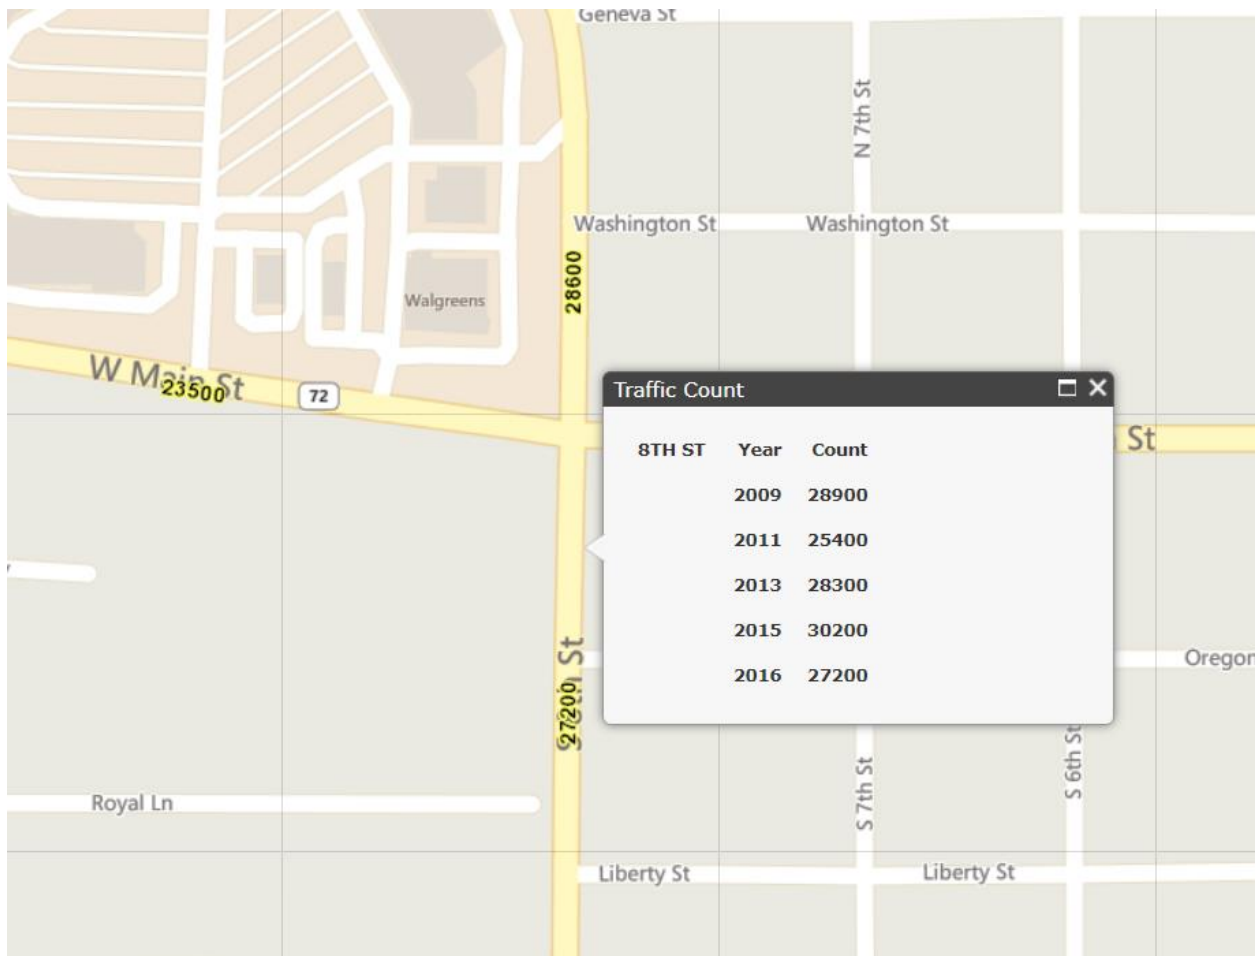
IL 31 (Northbound)

- 31,700 (2005)
- 30,000 (2007)
- 28,900 (2009)
- 25,400 (2011)
- 28,300 (2013)
- 30,200 (2015)
- 27,200 (2016)

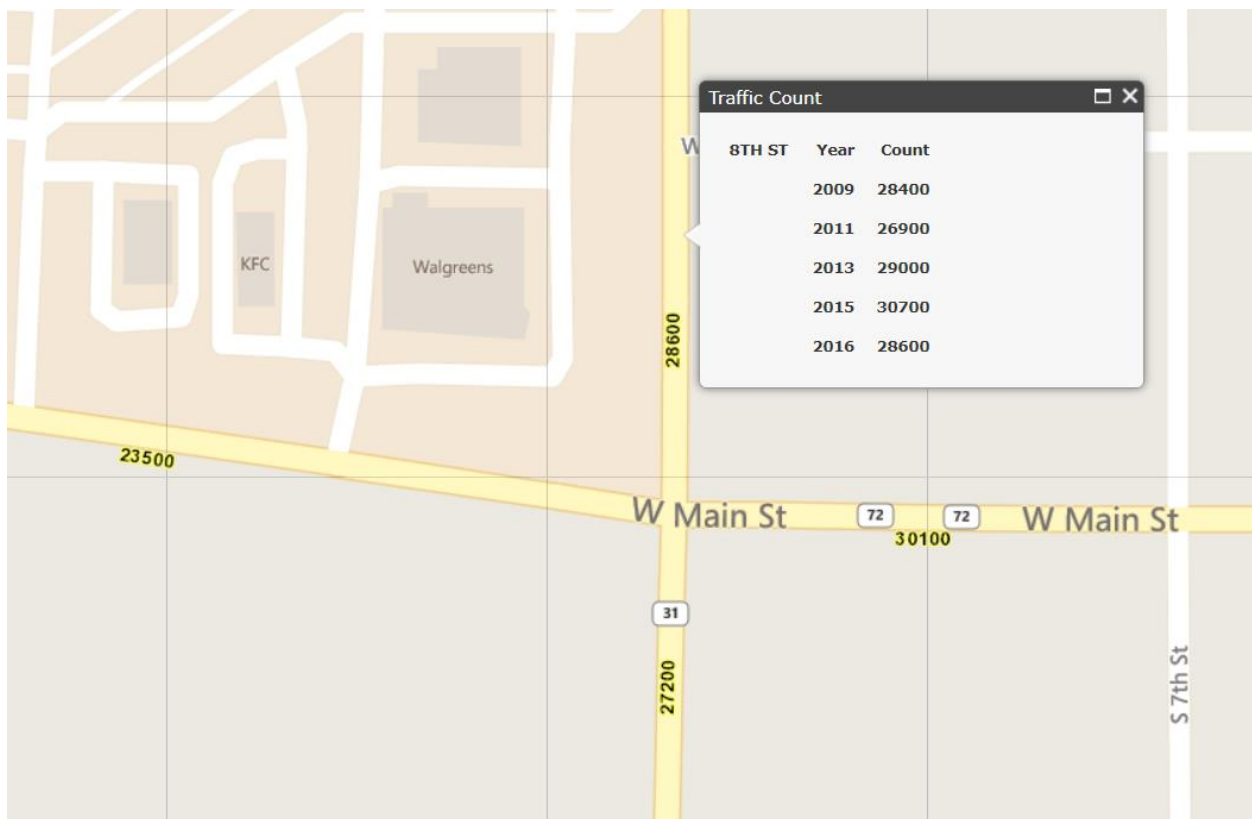
IL 31 (Southbound)

- 29,600 (2005)
- 29,800 (2007)
- 28,400 (2009)
- 26,900 (2011)
- 29,000 (2013)
- 30,700 (2015)
- 28,600 (2016)

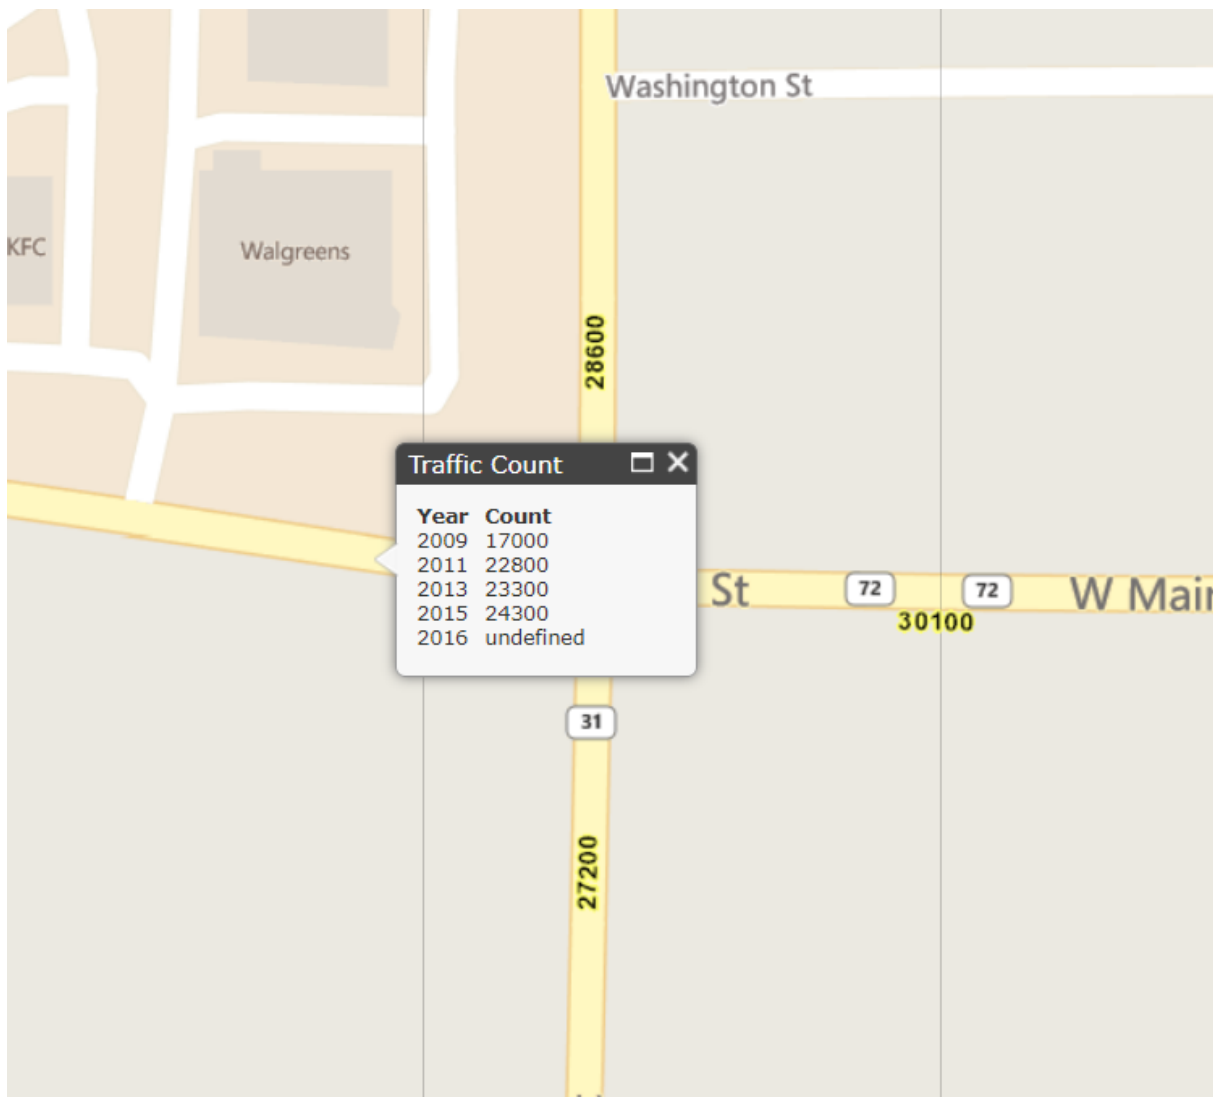
IL 72 (Eastbound)

- 19,800 (2005)
- 18,700 (2007)
- 17,000 (2009)
- 22,800 (2011)
- 23,300 (2013)
- 24,300 (2015)

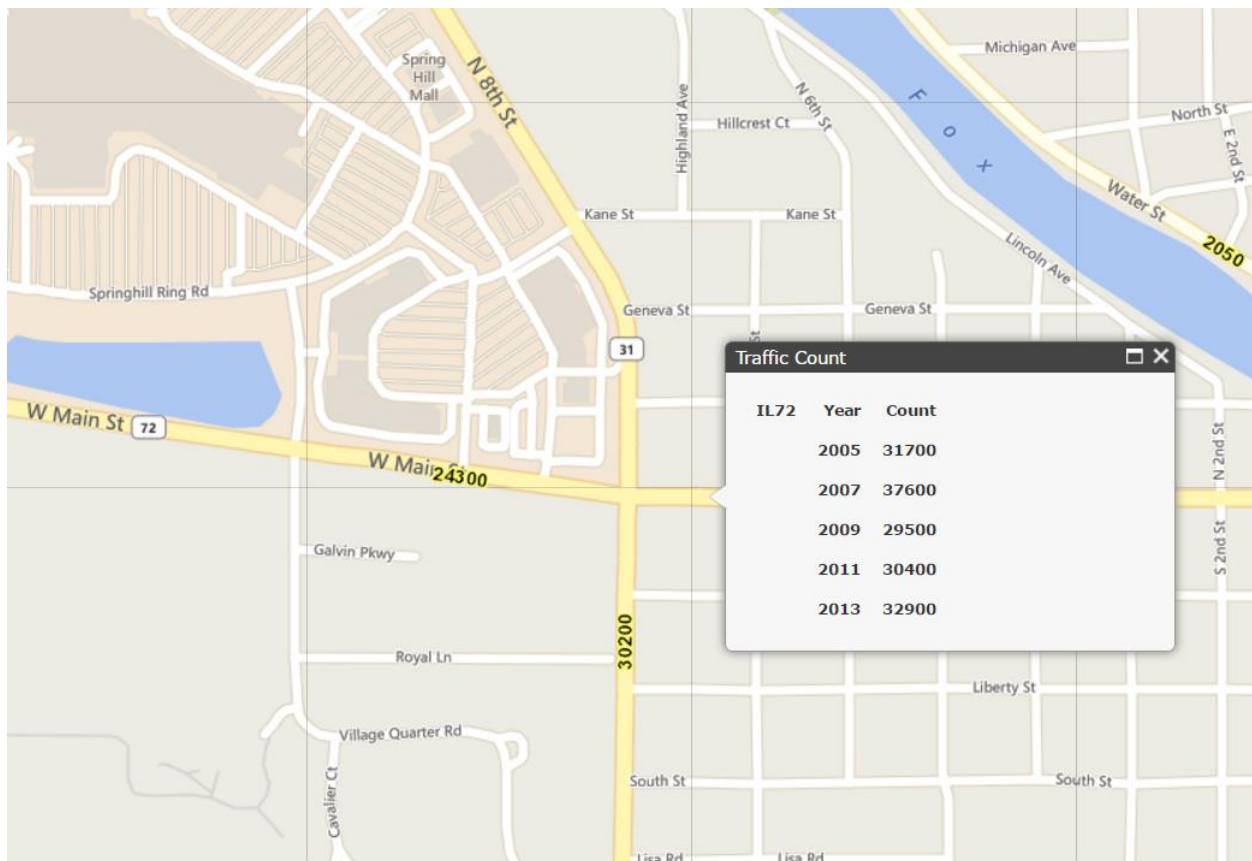
IL 72 (Westbound)

- 31,700 (2005)
- 37,600 (2007)
- 29,500 (2009)
- 30,400 (2011)
- 32,900 (2013)
