A Red Light Running (RLR) Photo Enforcement System was installed at the intersection of IL Route 31/ 8<sup>th</sup> Street and Boncosky Road on September 1, 2008 after finding limited success with other attempted measures to promote safer driving and improve compliance with traffic laws. As a condition of use, both Illinois law and the Illinois Department of Transportation require periodic statistical analyses / evaluations be conducted.

## **Route 31 at Boncosky Road** **West Dundee, IL**

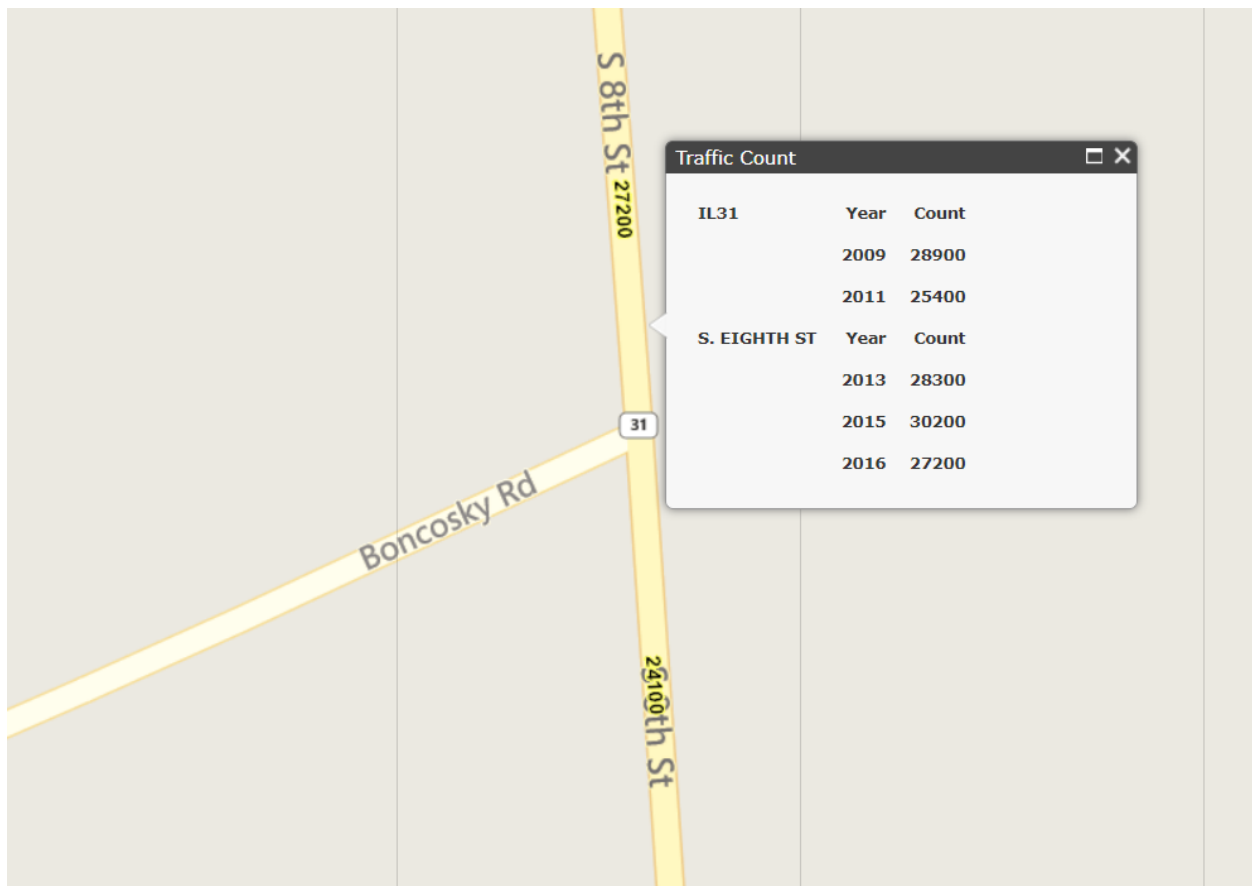
### Route 31 (Southbound)

- 31,700 (2005)
- 30,000 (2007)
- 28,900 (2009)
- 25,400 (2011)
- 28,300 (2013)
- 30,200 (2015)
- 27,200 (2016)

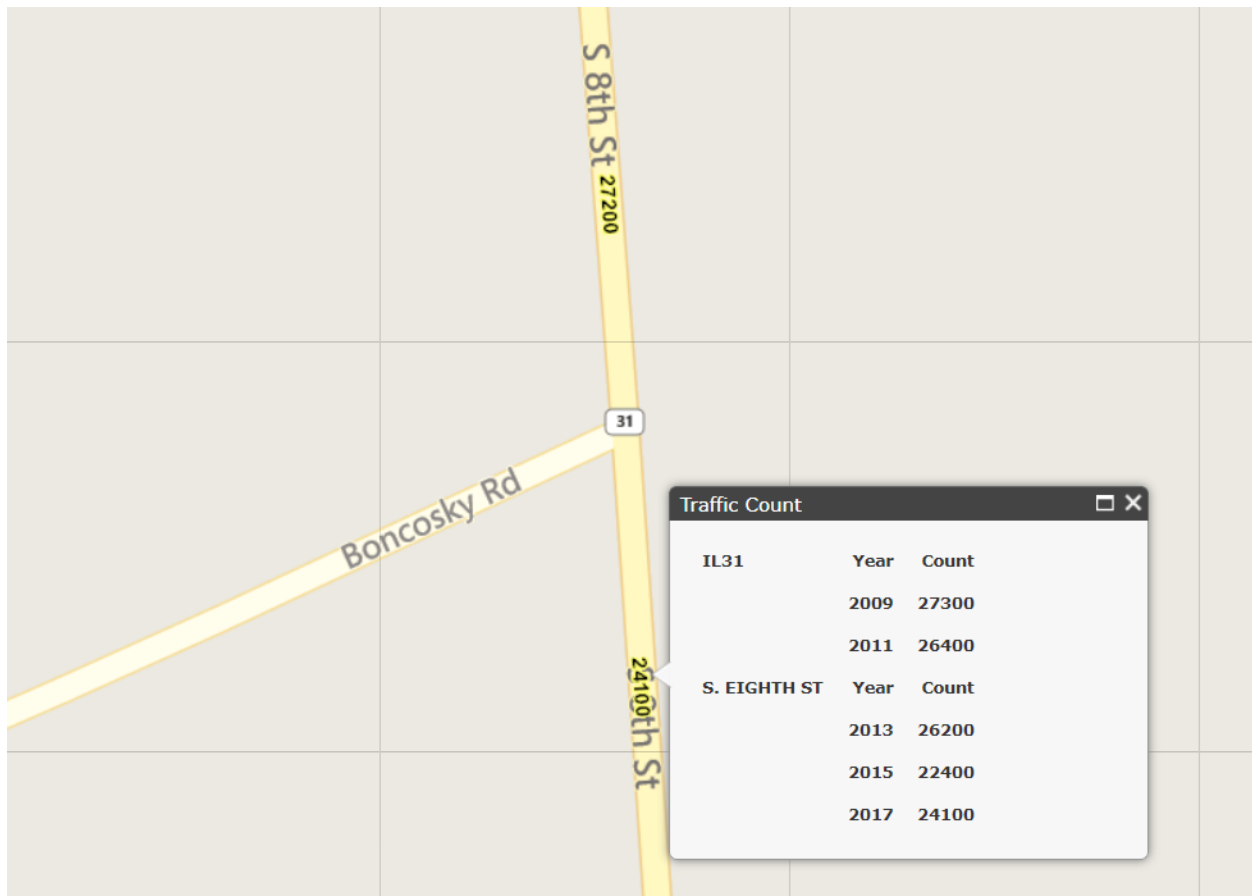
### Route 31 (Northbound)

- 27,600 (2005)
- 26,800 (2007)
- 27,300 (2009)
- 26,400 (2011)
- 26,200 (2013)
- 22,400 (2015)
- 24,100 (2017)

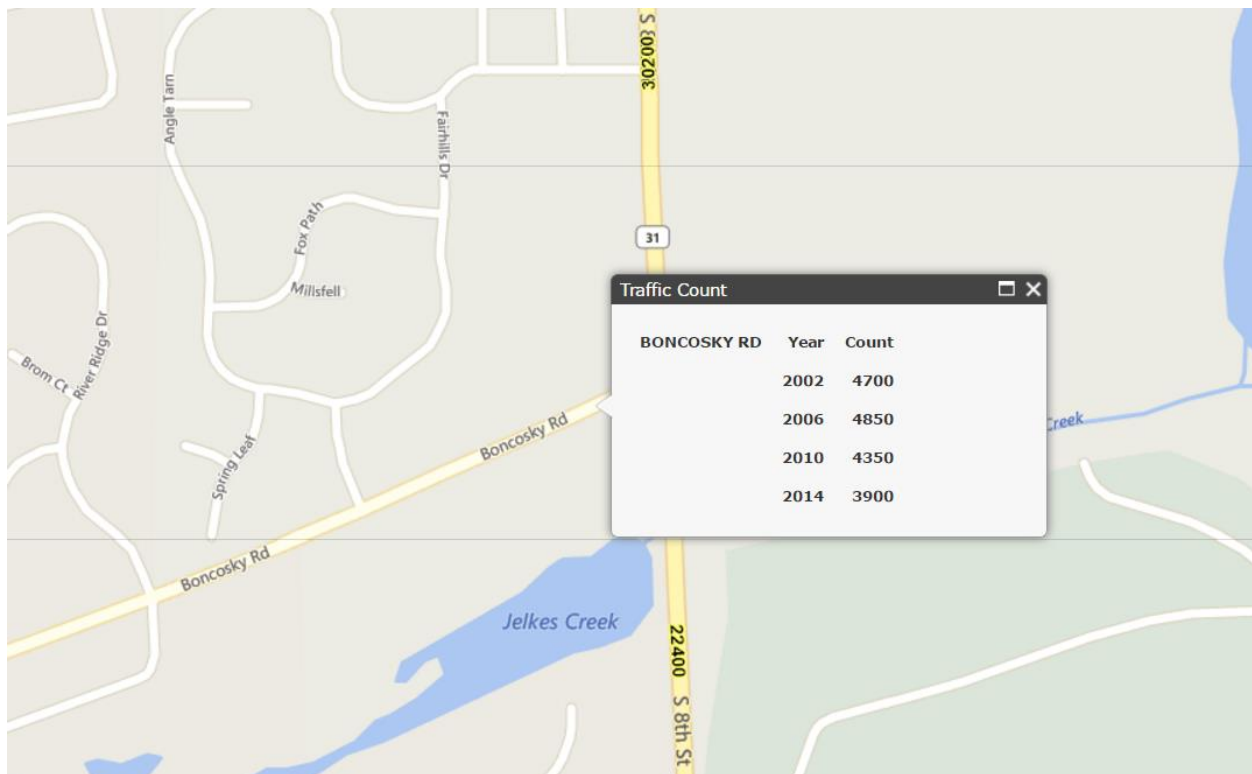
### Boncosky Road (Eastbound)

- 4,700 (2002)
- 4,850 (2006)
- 4,350 (2010)
- 3,900 (2014)
